616 N Broadway  
Structural Stabilization

# **BUILDING CONDITION ASSESSMENT**

**616 NORTH BROADWAY, PITTSBURG, KANSAS 66762**

**D2 Annex, Engineering Solutions  
Jim R Zibert, P.E.  
Kansas PE License #12273**

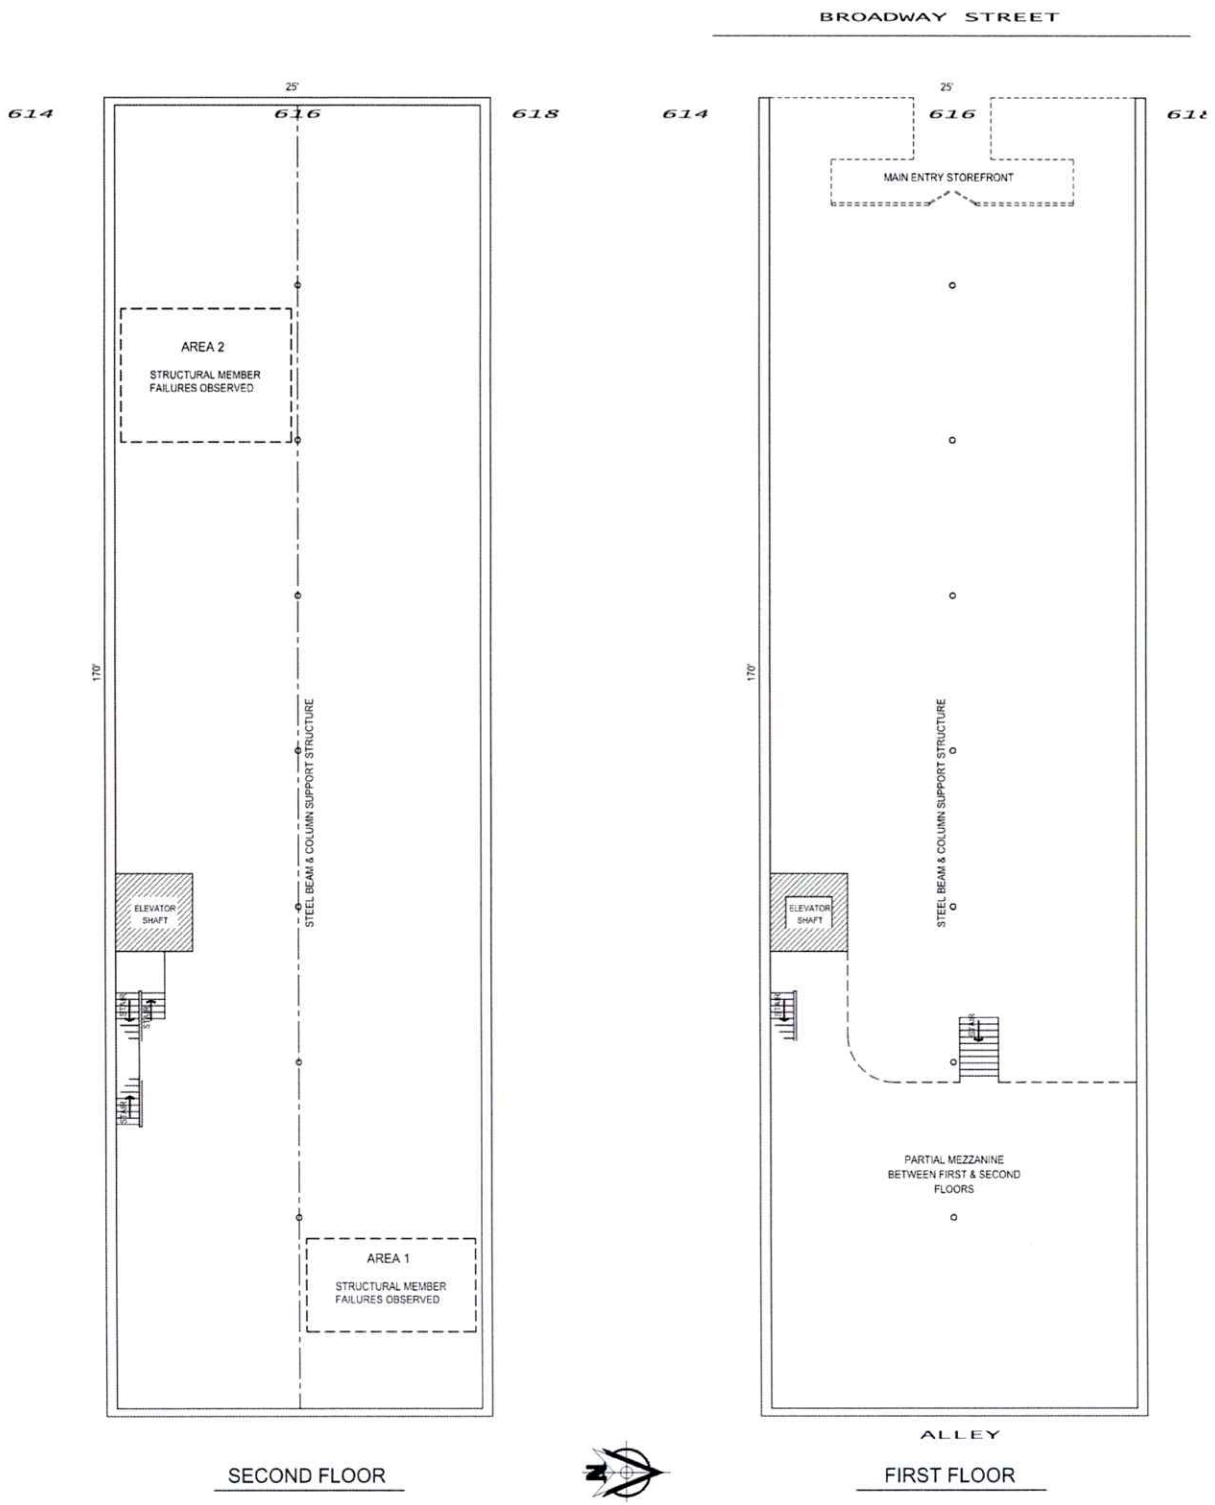
Figure 1

Building floor plans are given in Figures 1 & 2 that identify Areas within the building described within this report.

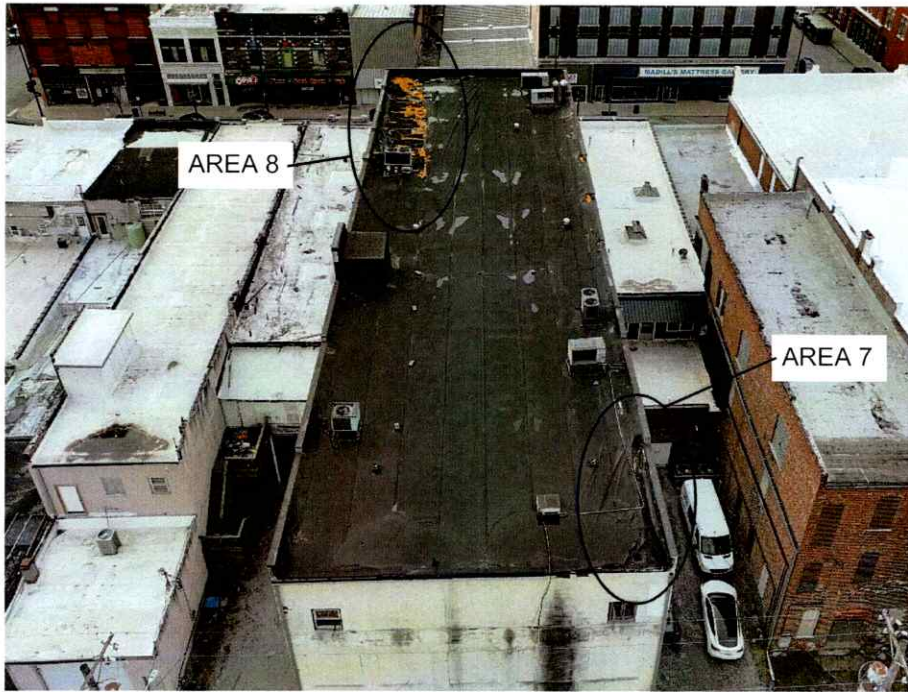
The roof of this building is currently extensively compromised and a large portion of moisture and rainwater that lands upon this roof, goes directly inside the structure. This condition is not recent in nature and has been occurring for a good number of years. The EPDM membrane is detached and blown away at Areas 7 & 8 and extensive damage to the roof decking is seen. We were unable to determine what the condition of the roof trusses were in, but we strongly suspect that they are compromised based on what was seen in the drone photos and observed from the third floor below. It should be noted that directly below these two areas, the third floor had collapsed which prevented closer inspection. Determining isolated roofing conditions to the membrane seams and wall flashings utilizing aerial photos is normally problematic but experience inspecting these type roofs under similar conditions and from what is viewed from the underside, tells us that this roof has a good many problems at these other locations.

Overall view of building roof.

The first item that needs to be addressed is temporarily weatherproofing the roof. Naturally, safety is of primary concern, and conditions present will make the temporary repairs tedious. Plywood sheeting should be placed for use by the workers in accessing repair areas. All workers should be required to wear fall protection at all times with lanyards secured to tie off points installed before any work is done. Temporary

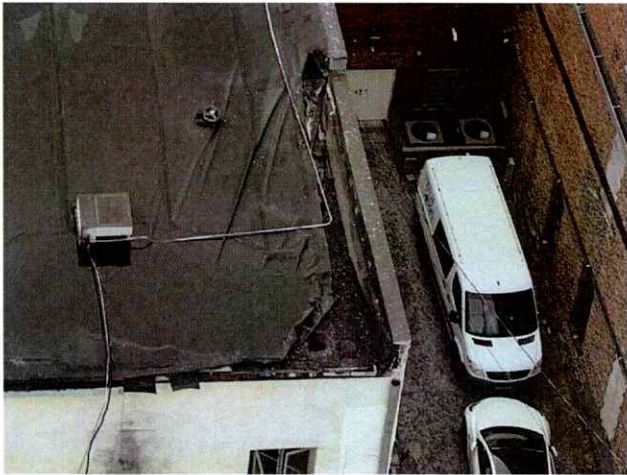
Enlarged View of Building Roof Area 7

weatherproofing at Areas 7 & 8 is of high importance as well as any other significant roofing problems found. Everyone should keep in mind that this weatherproofing is only temporary and more permanent repairs will take place after the floor and roof structures have been stabilized from within.

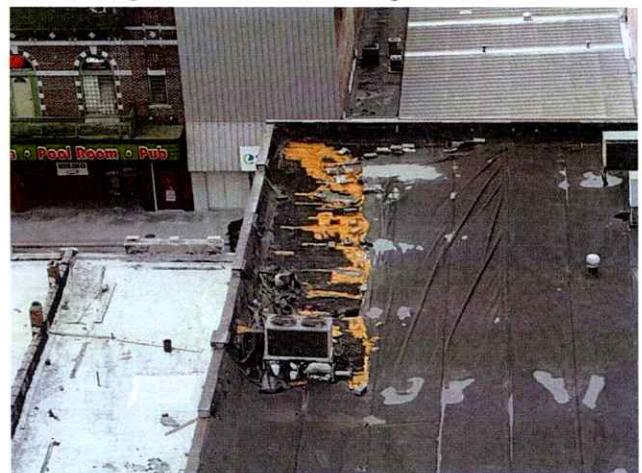
Enlarged View of Building Roof Area 8

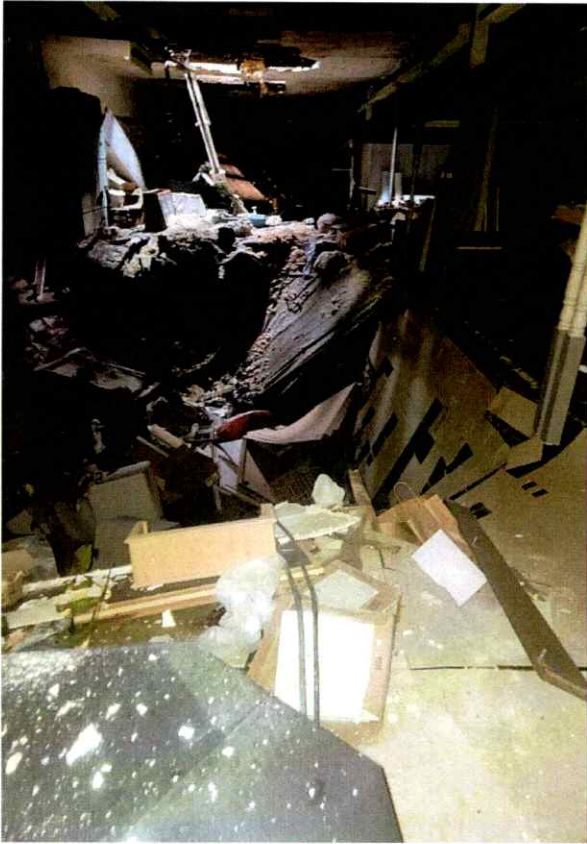
The third floor is experiencing widespread buckling of the floor deck due to prolonged saturation from rainwater and moisture. Saturation of the wood joists below varies throughout. In Areas 3, 5 & 6 damages to the structural system from saturation coupled with saturation of the large volume of "clutter" in these locations have led to total collapse of the floors. Floor joists in Areas 5 & 6 experienced failures at their midspan while the floor joists in Area 3 experienced failures at their supports in the masonry bearing wall. Those Areas 3, 5 & 6 of the third floor that have collapsed now reside on the second floor and even though no collapses of the second floor were observed, local member failures were observed due to water saturation and overloading. Area 4 on the third floor was in the advanced stages of failures with collapse not being far away. We observed excessive vertical displacements at the joist supports in the north masonry bearing wall with maximums of 6" observed.

Area 5 Floor Collapse viewed from 3rd Floor

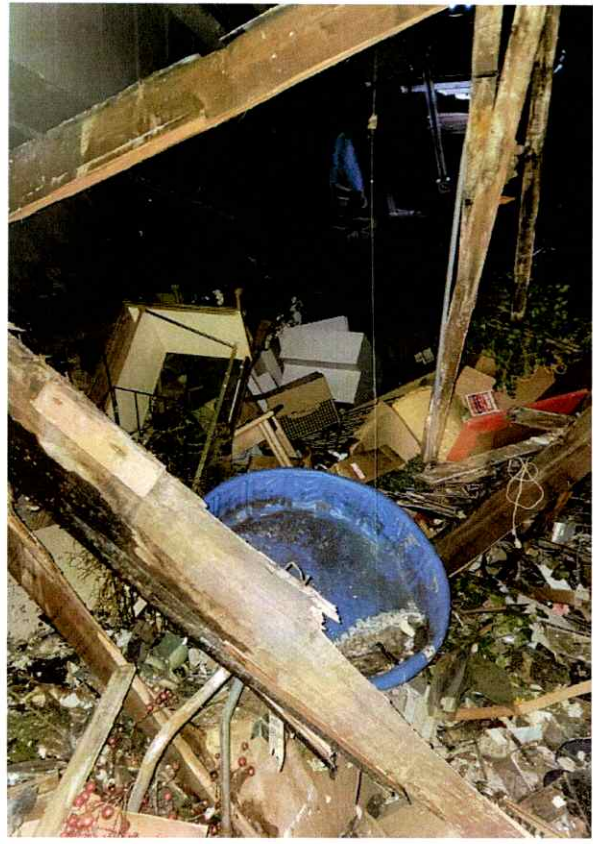
Area 5 Floor Collapse viewed from 2nd Floor

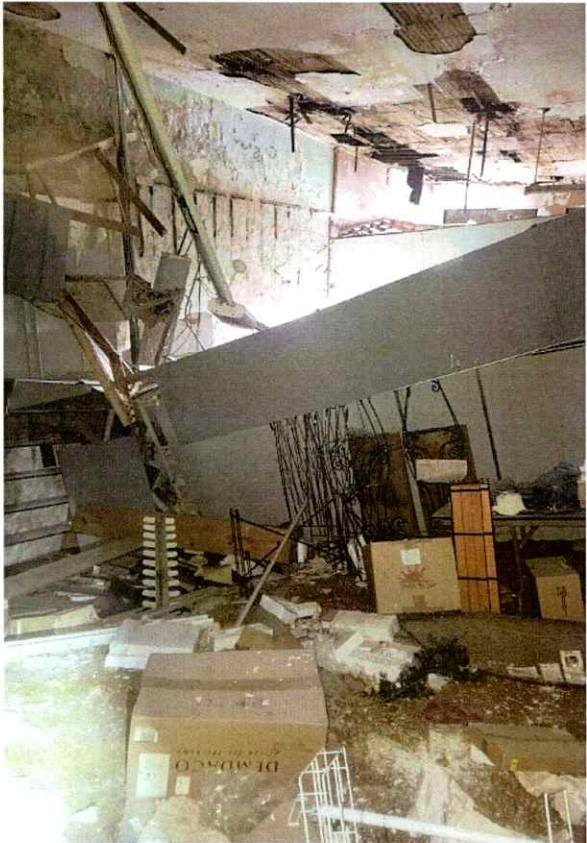
Area 3 Floor Collapse viewed from 3rd Floor

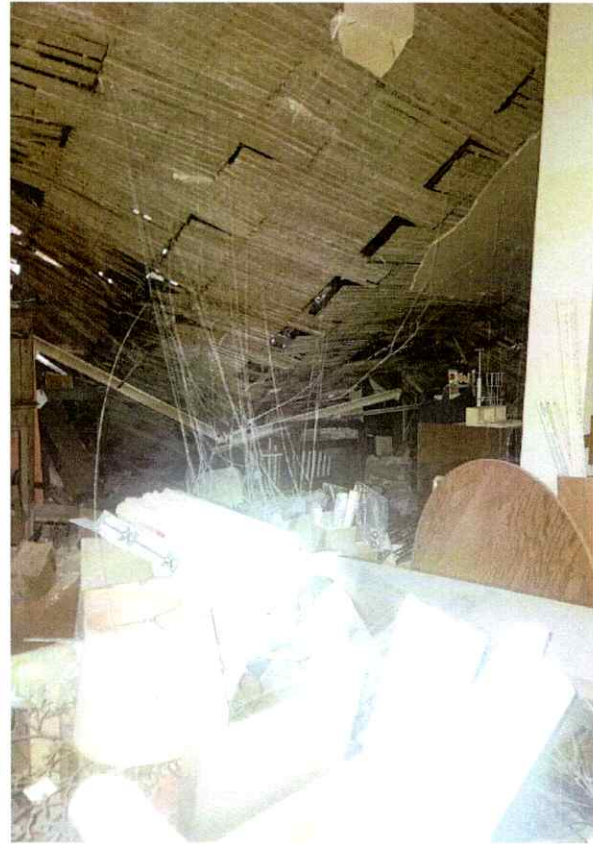
Area 3 Floor Collapse viewed from 3rd Floor

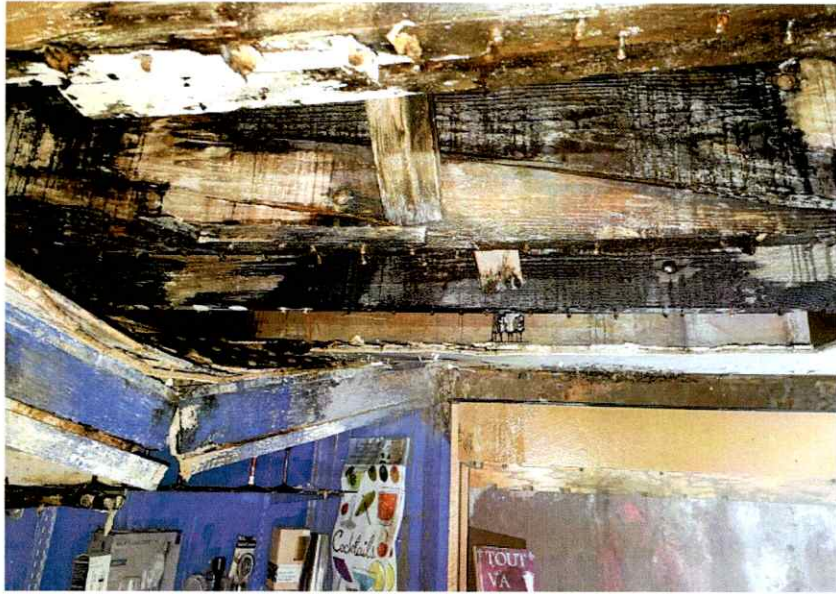
Although no collapsing of the floor system were viewed on the second floor, localized failures to the floor joists were observed in Areas 1 & 2. This was more than likely due to excessive loading from the collapsed third floor with associated "clutter", coupled with water saturation of the floor framing. Both of these areas, as well as all the other areas defined, are in critical condition. The second floor deck is also buckling like the third floor only not to the same extent. Saturation of the wood joists varies throughout.

Area 1 Floor Joist Failure viewed from Mezzanine

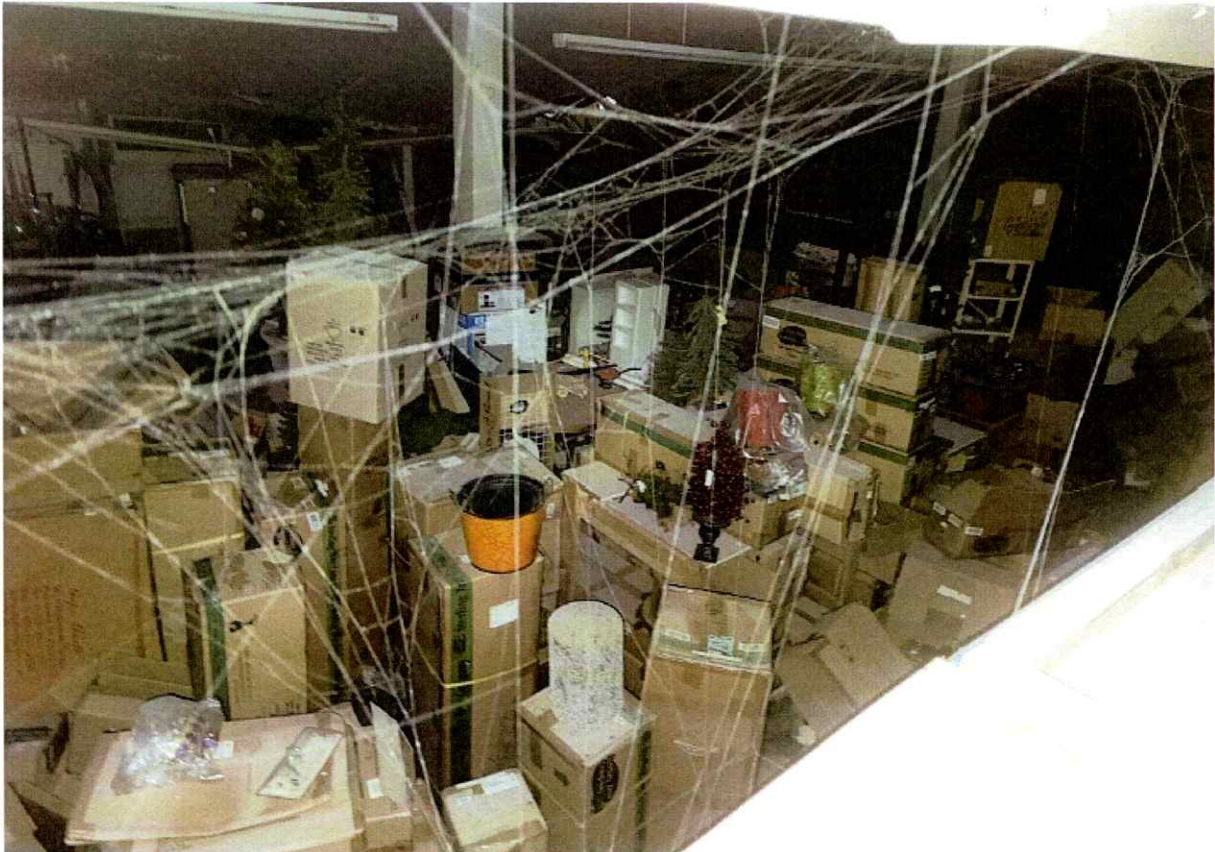
It needs to be noted here that access to a vast majority of this structure was inhibited due to the presence of an inordinate amount of "clutter" stored on all floors within the building and due structural collapses to areas of the floor framing. The extensive volume of "clutter" stored or present on all floors within the building restricted movement to a limited number of narrow passageways that existed between this "clutter". For the lack of a better, more defined word, the term "clutter" is used herein is defined to be anything from clothing, furnishings and paperwork to decorations and other knick knacks and just about anything else that one can imagine.

Representative view Showing Volume of Clutter Stored on the Building 2nd Floor

"Clutter" removal will be done utilizing trash chutes with drop bins installed at both the street and alley parts of the building. Travel on the floors will be limited to plywood sheeting placed to create walkways. Use of trash buggies for "clutter" removal can be utilized. These buggies are to be load limited and to be the push type and nonmotorized or mechanically assisted for movement.
