616 N Broadway  
Structural Stabilization

# **BUILDING CONDITION ASSESSMENT**

**616 NORTH BROADWAY, PITTSBURG, KANSAS 66762**

**D2 Annex, Engineering Solutions  
Jim R Zibert, P.E.  
Kansas PE License #12273**

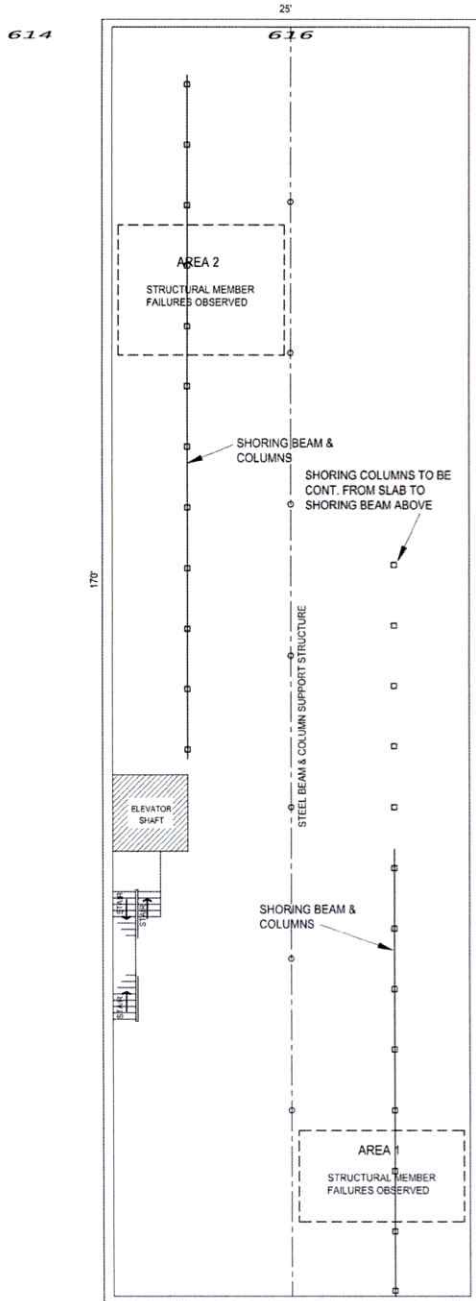
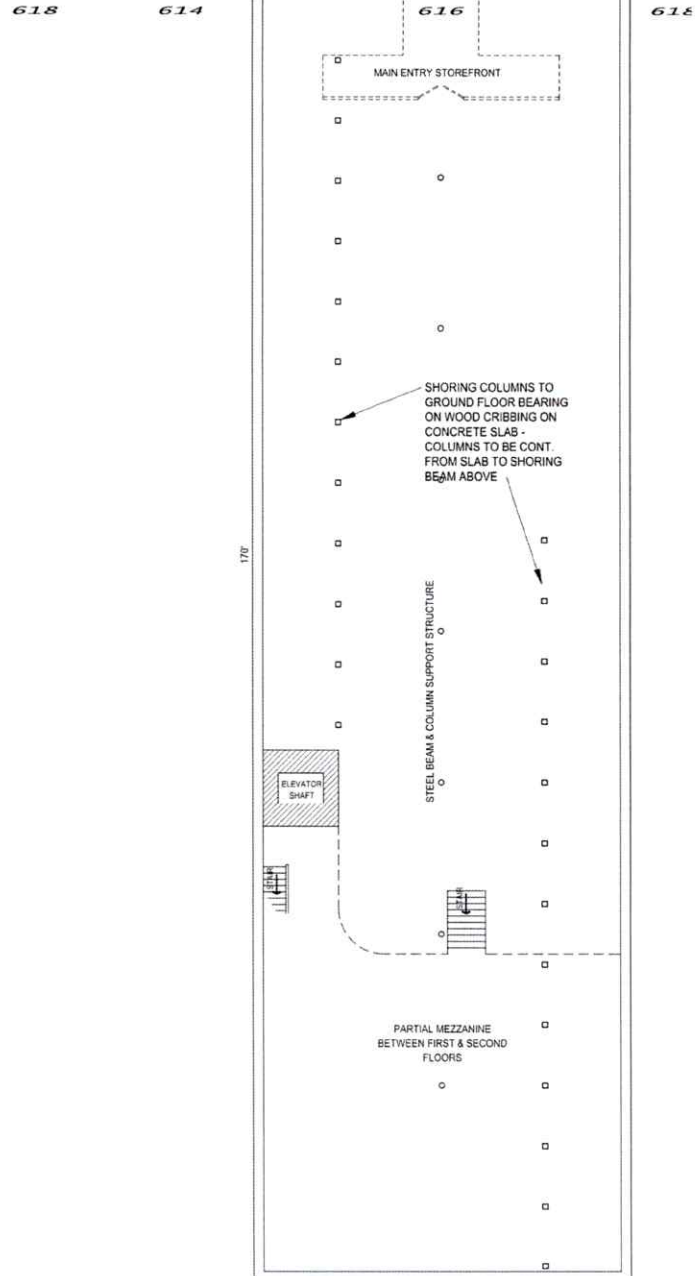
Figure 3

It is our opinion that this building can, and should, be saved. We are providing herein a general plan to provide stability to the structure for the short term until more permanent remediation can take place. The stabilization plan described is to be taken as descriptive and used for planning purposes only. Design and implementation of the shoring and stabilization plan should be prepared by a qualified engineer. An engineer should also be employed for inspection of installed shoring and also to continuously monitor the structure for any movements during “clutter” removal and shoring operations. Figures 3 & 4 depict preliminary locations and extent of shoring beams and columns to be installed.
